<b>NASA Engineering and Safety Center Technical Report</b>	Document #: <b>RP-07-47</b>	Version: <b>5.1</b>
Title:	<b>STS-117 Hail Damage Repair Assessment</b>		Page #: 1 of 114

# **Space Transportation System (STS)-117 External Tank (ET)-124 Hail Damage Repair Assessment**

**May 24, 2007**

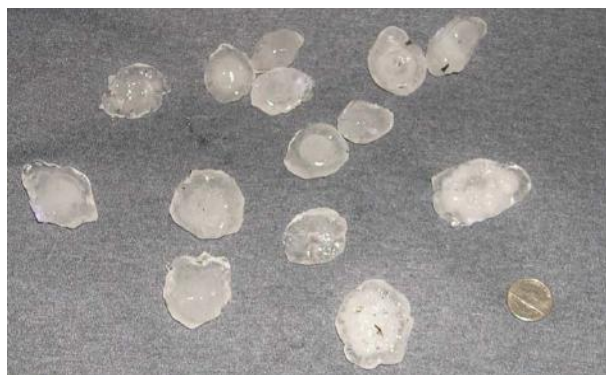
**Figure 6.1-1. Hail from the February 26, 2007 storm [ref. 26]**

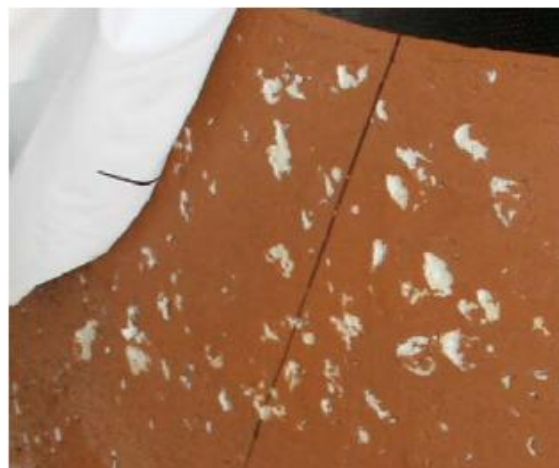
Severe thunderstorms with associated hail and high winds struck the STS-117 stack on February 26, 2007 while at Launch Pad 39. Peak winds were recorded at 62 knots with hail size ranging from 0.3 inch to 0.8 inch in diameter as shown in Figure 6.1-1. The NCFI 24-124 foam on the LO2 tank ogive acreage and the ET intertank incurred significant damage. NCFI on the ET intertank and PDL 1034 foam of the LO2 IFRs suffered minor damage, as did the LO2 tank cable tray SLA. An example of the resulting damage is shown in Figure 6.1-2.

**Figure 6.1-2. Example of Hail Damage to ET-124 TPS [ref. 27]**

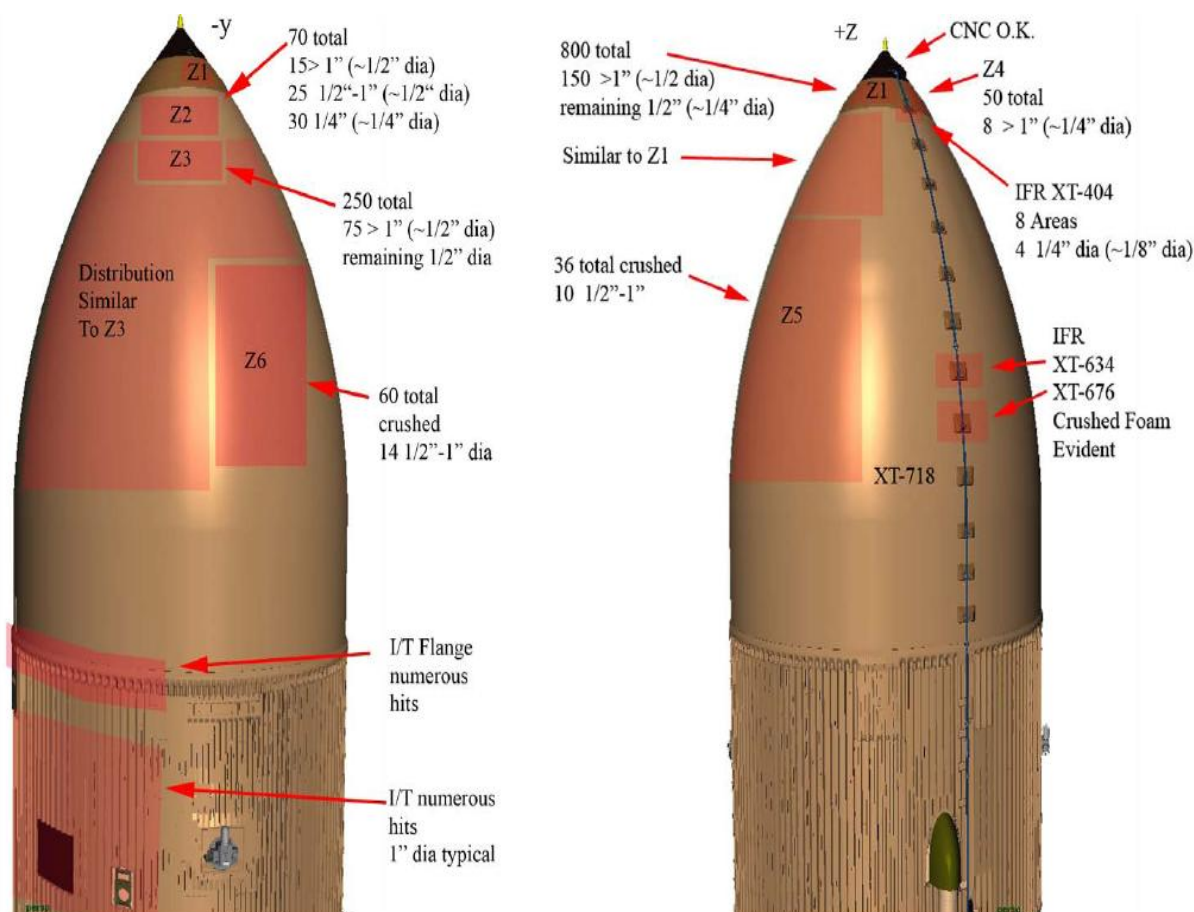
In the initial damage assessment [ref. 3], the ET Project reported that the nose cone and machined surface of the LO2 ogive TPS had suffered a significant number of impacts. As Figure 6.1-3 depicts, impact damage to ET-124 was sustained around the entire circumference with the heaviest concentration on the +Z side with more than 1200 hits. There were numerous areas of damaged foam in the LO2 tank acreage TPS with the heaviest concentration in the +Z and -Y quadrants. Minor damage was observed on the inboard side of all LO2 IFRs with crushed foam observed on the IFRs at stations Xt-634 and Xt-676. Numerous areas of damaged NCFI were observed in the intertank area with the heaviest sustained in the -Z quadrant. Additional less severe damage was also observed in the +Z quadrant. Fewer than 12 hits were observed on the LH2 acreage TPS. Minor damage was observed on the -Y ET / Solid Rocket Booster (SRB) ramp aft fairing and cable tray and on the forward face of the LH2 IFRs.

**Figure 6.1-3. Initial Assessment of Hail Damage to ET-124 [ref. 4]**

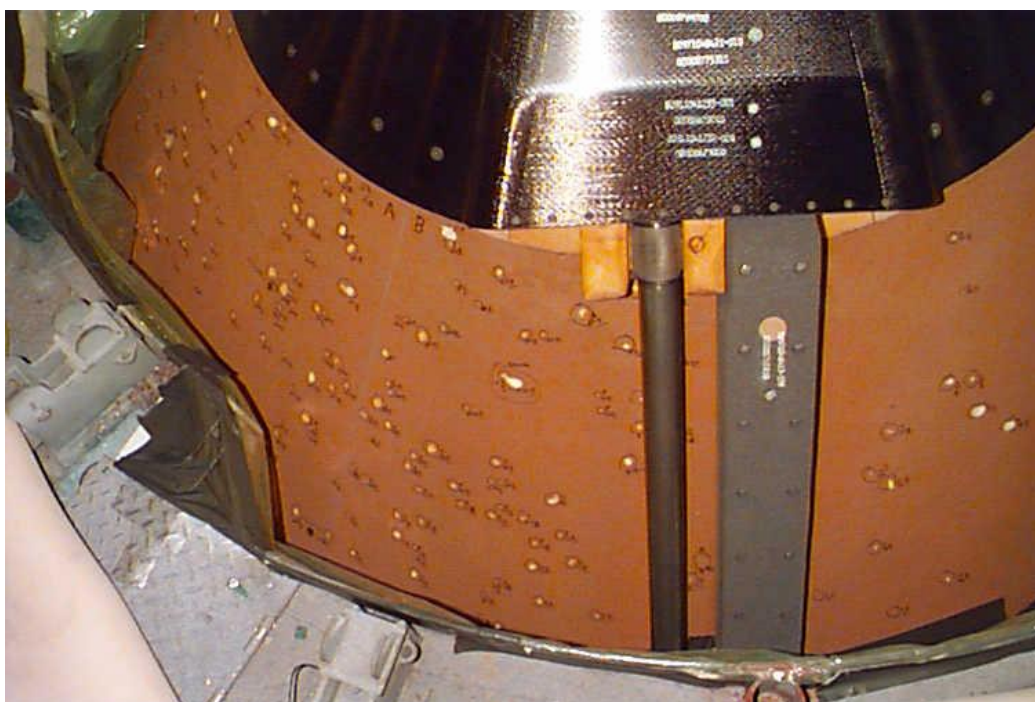
**Figure 6.2-3. STS-96 ET-100 Typical Hail Damage**

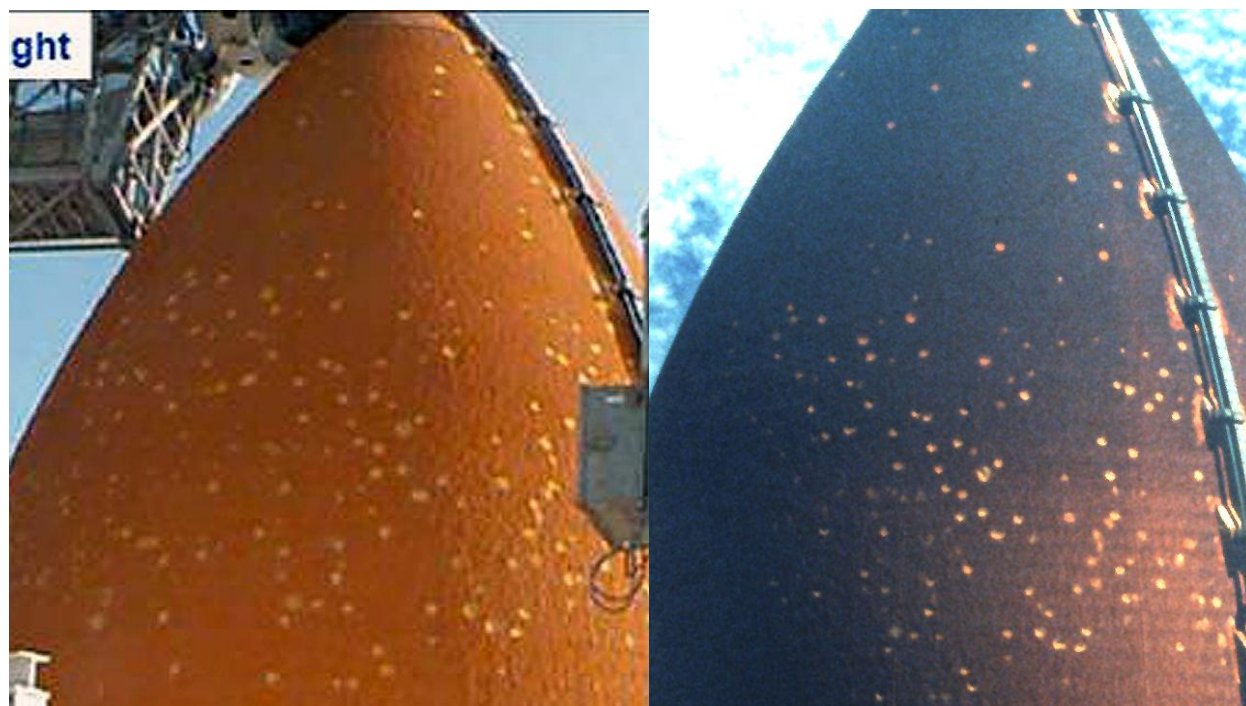
The LO2 tank acreage had visible condensate but no ice or frost formations. All hail repairs were intact and exhibited no thermal shorts. No anomalies were detected on the inter-tank. The LH2 tank acreage had condensate but no ice or frost formations. After the pad was cleared for launch, the Ice Inspection Team continued to monitor the vehicle with remote cameras and infra-red radiometers. There was no ET acreage ice observed and no noticeable increase in protuberance icing was detected. The report did indicate that there was extensive surveillance of the hail damage to verify repair integrity and the absence of ice formation.

**Figure 6.2-4. STS-96/ ET-100 Pre- and Post- Launch Comparison**

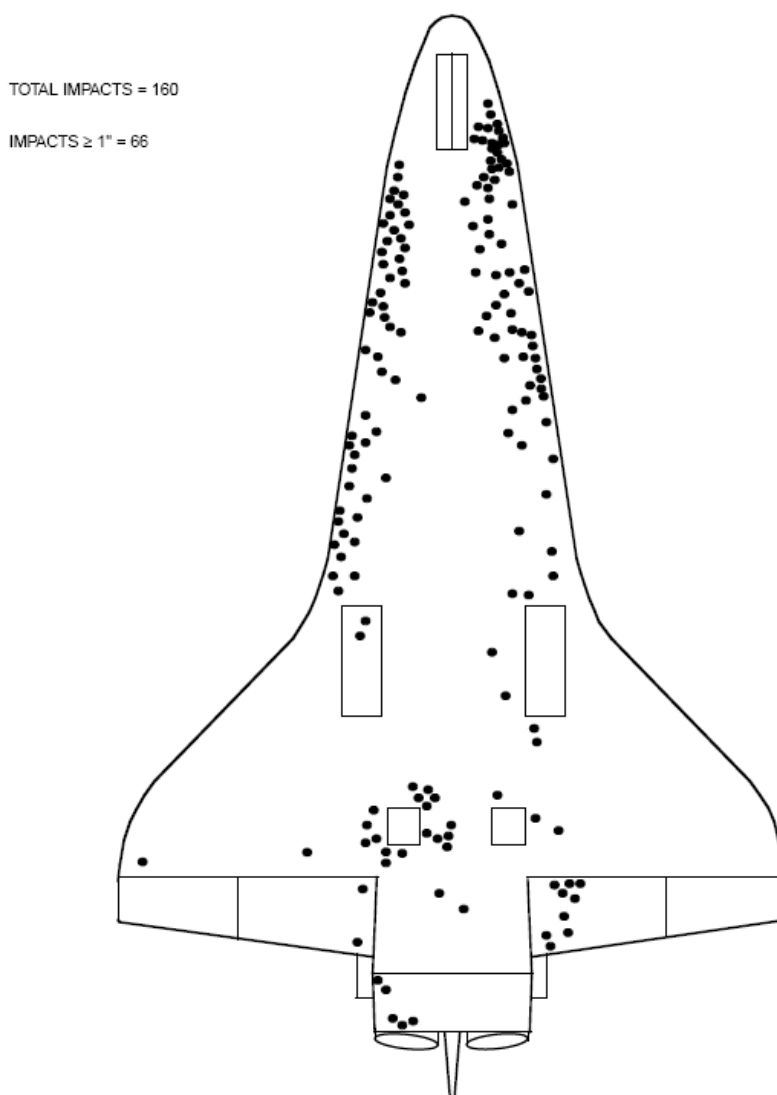
Post-landing debris impact assessment of the Orbiter indicated 160 lower surface hits of which 66 were greater than 1 inch. Boeing's post-landing report for STS-96 [ref. 16], noted that most of the damage was concentrated from the nose gear to the main landing gear wheel wells on both left and right chines as shown in Figure 6.2-5.

**Figure 6.2-5. Lower Surface Orbiter Damage**

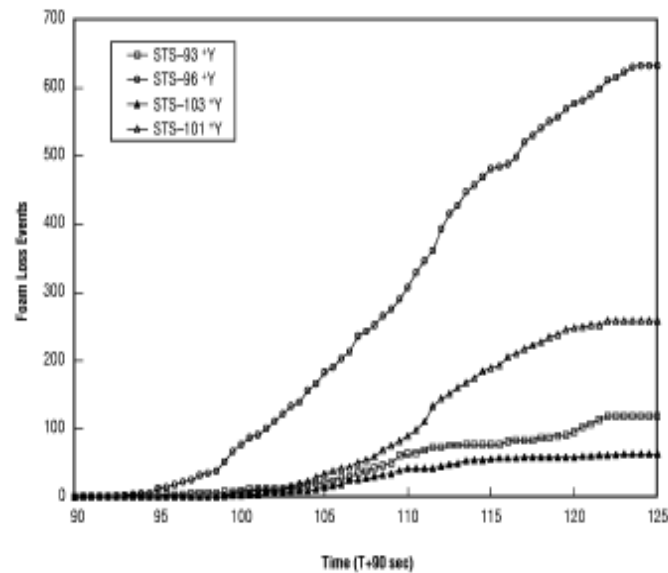
**Figure 6.2-6. Foam Loss Comparisons for +Y Intertank Thrust Panels**

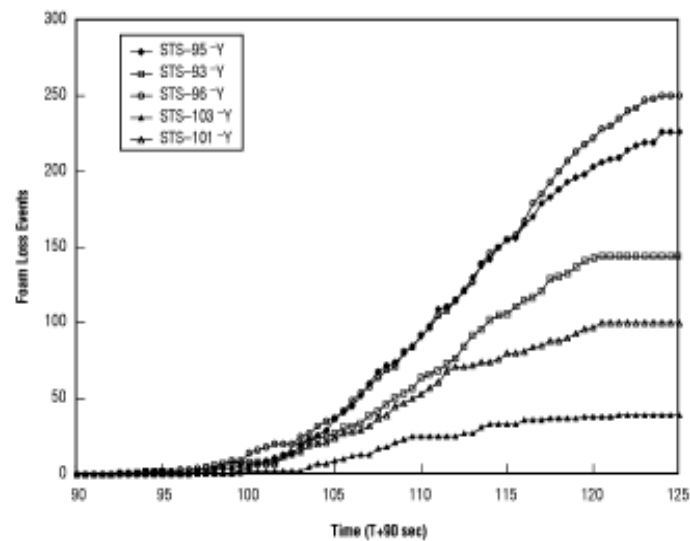
**Figure 6.2-7. Foam Loss Comparisons for +Y Intertank Thrust Panels**

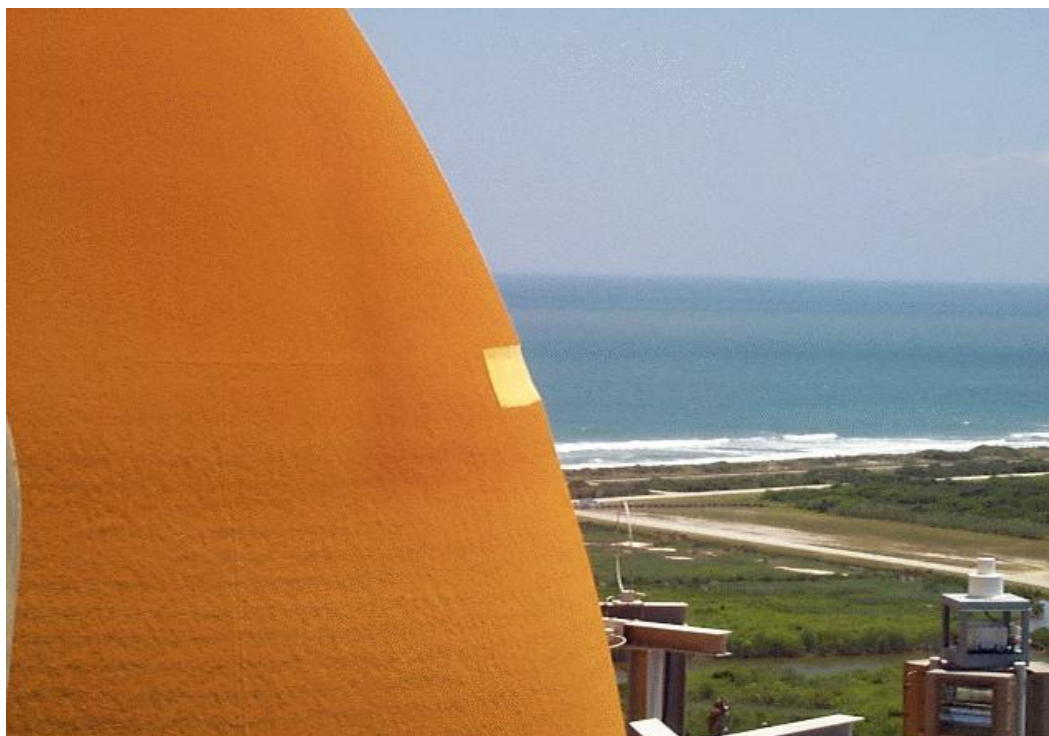
relieve NCFI foam induced compression loading on a LO2 ogive weld joint. The groove was approximately 14 inches wide, by 6 feet length, 1 inch deep; it was created by sanding and blending the NCFI. While the modification created significant surface waviness, flight photos showed no evidence of abnormal erosion or significant foam loss from the LO2 tank (Figure 6.2-8).

**Figure 6.2-8. STS-91 LO2 Tank Stress Relief Groove**

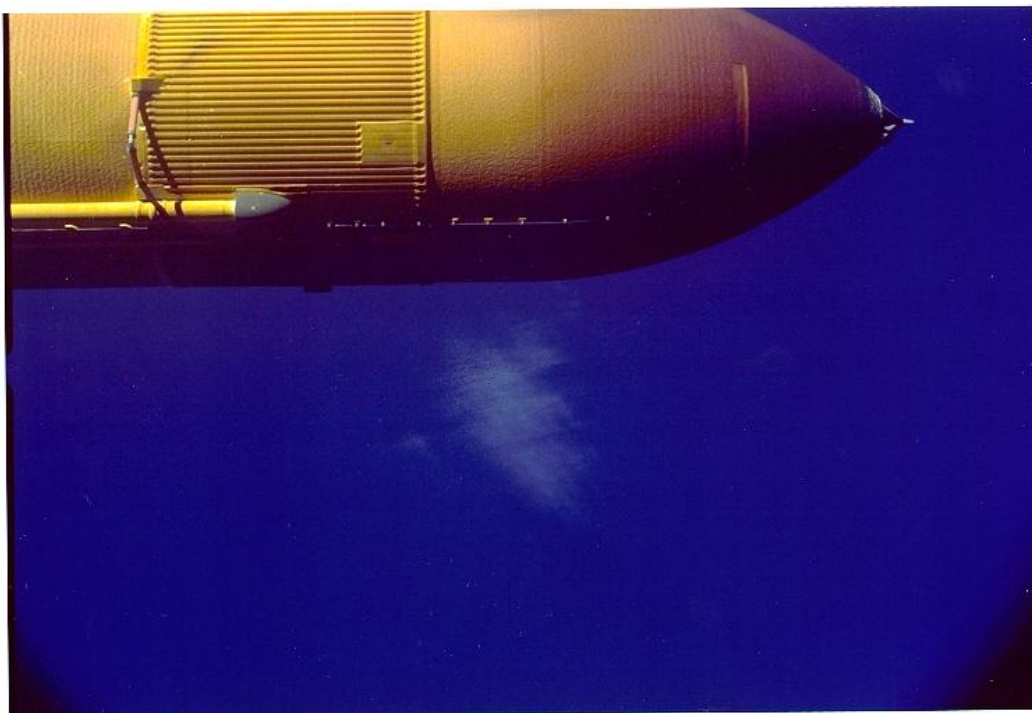
**Figure 6.2-9. STS-91 Post-Separation Photo**

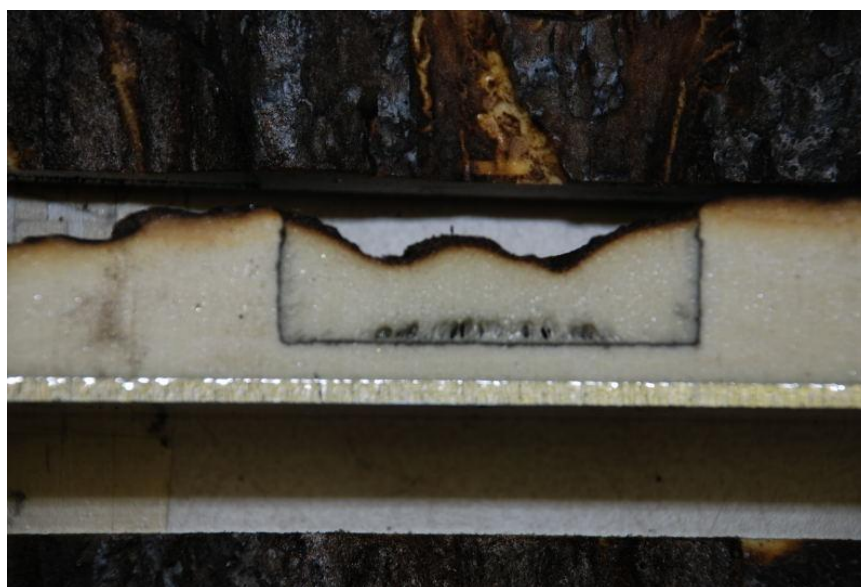
**Figure 7.3-7. Sectioned PDL Repair Following Hot Gas Test [ref. 5]**

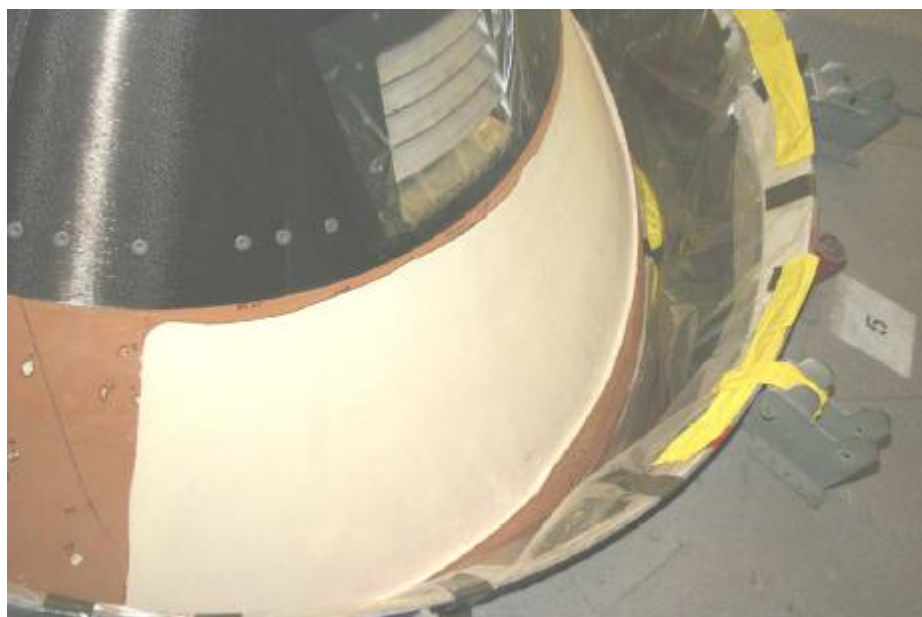
**Figure 7.3-9. Partial View of ET-124 Pencil Sharpener BX-265 Spray Repair Area [ref. 24]**
